New temporary option in BUDS to reset/clear cluster as new_139510

This new temporary reset option in BUDS will allow to flash the cluster for MY21 and MY22 units only.

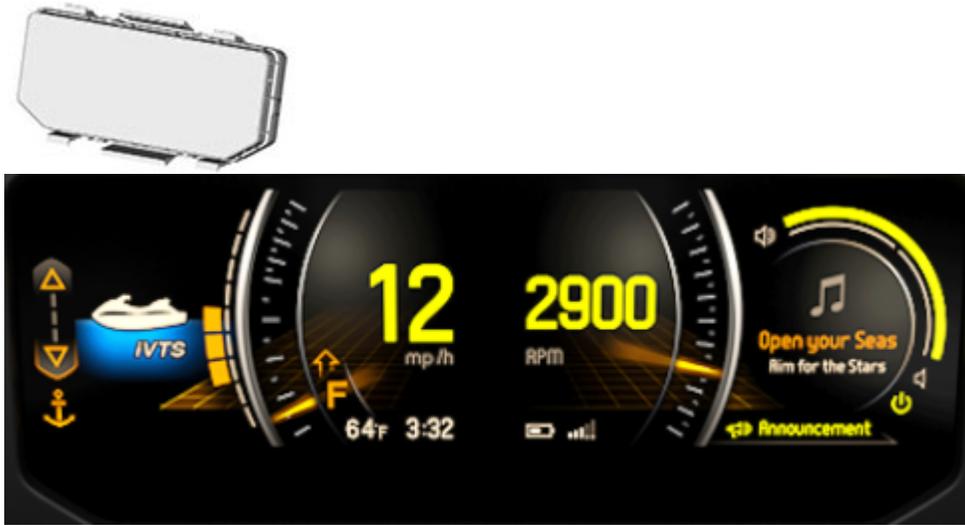
<p>Can not be reset DO NOT USE RESET FUNCTION</p>
